Ecological Evaluation – North, West and East Lake Coral Lakes, Oakland Park, Florida; Sections 14 & 23, Township 49E, Range 42S

Prepared For:
City of Oakland Park
Public Works Department
250 North East 33rd Street
Oakland Park, Florida 33431

North Lake Aerial Photograph
City of Oakland Park Water Quality Evaluation
North, West and East Coral Lakes
Sections 14 & 23, Township 49, Range 42

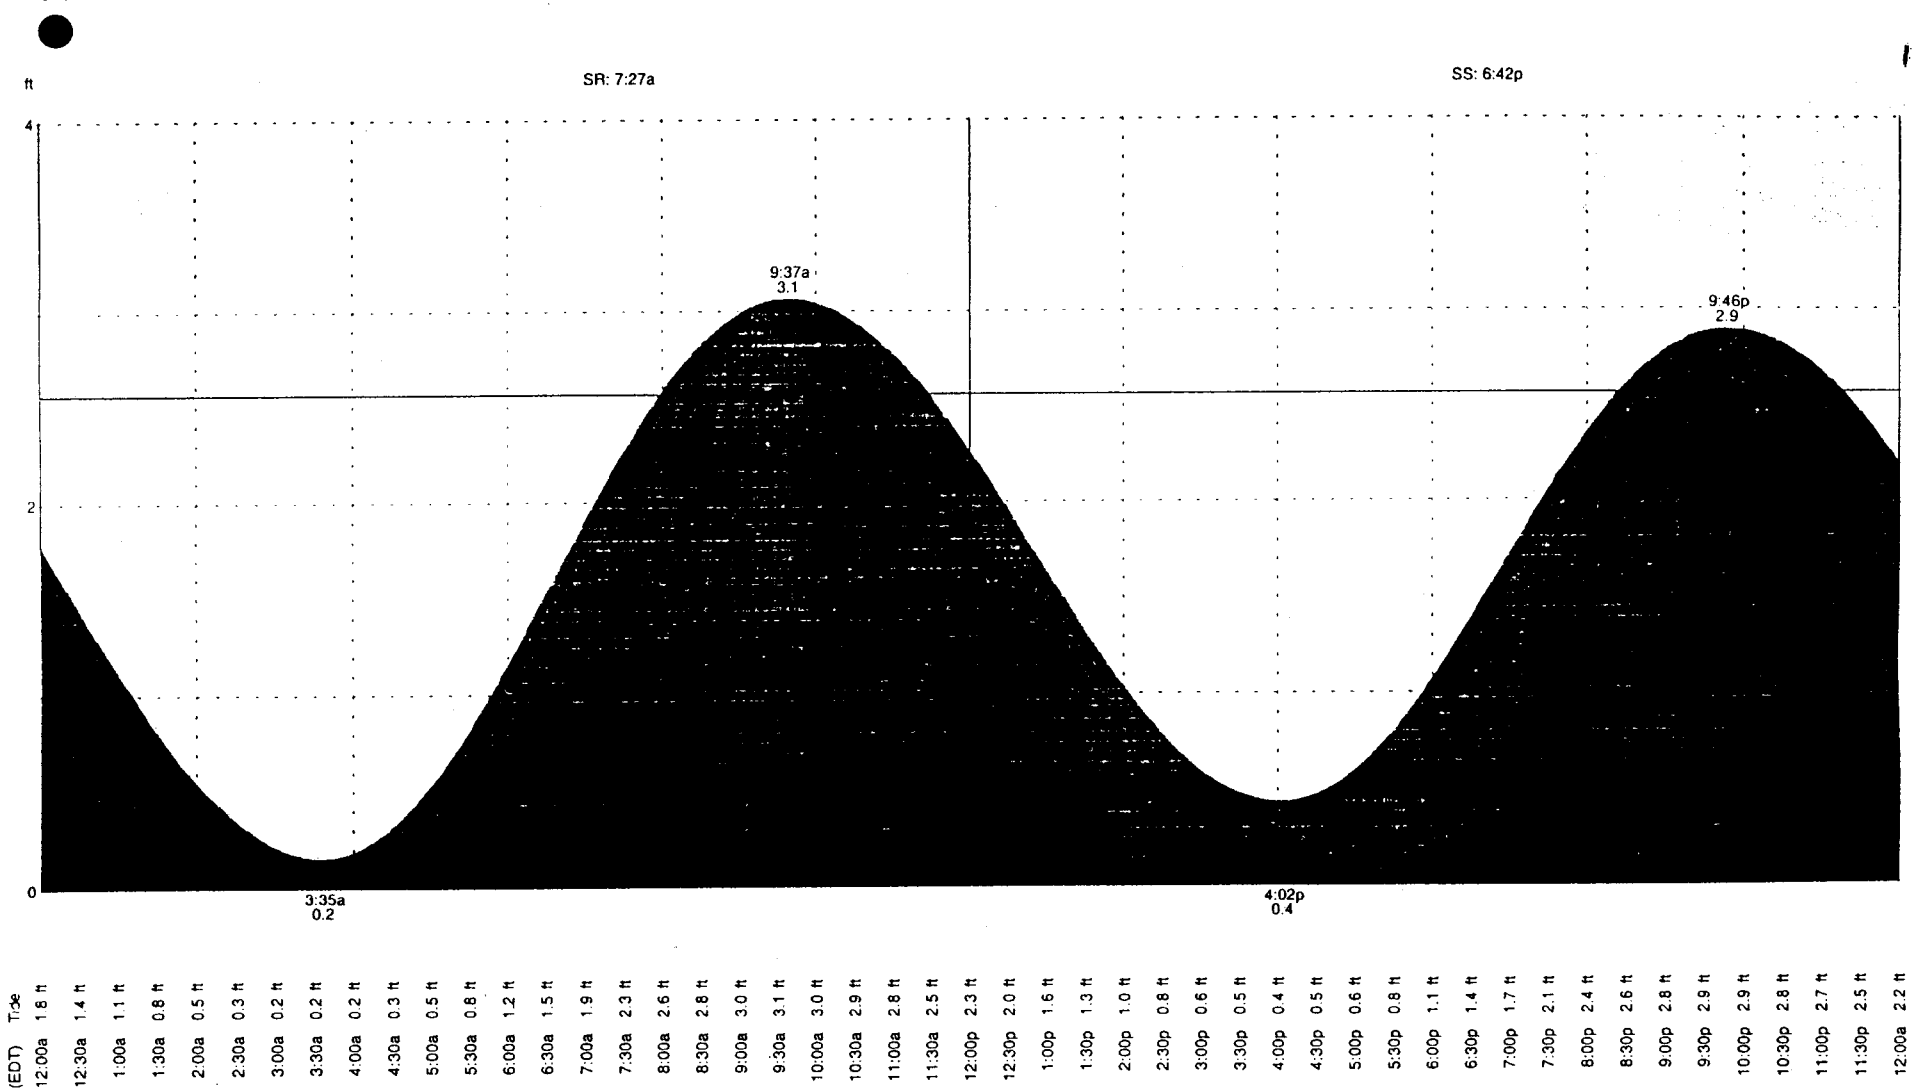
Average Tides
Mean Range: 2.1 ft
MHWS: 2.6 ft
Mean Tide: 1.2 ft

Daily Highs & Lows
3:35a 0.2 ft Low
9:37a 3.1 ft High
4:02p 0.4 ft Low
9:46p 2.9 ft High

(EDT)	Tide
12:00a	1.8 ft
12:30a	1.4 ft
1:00a	1.1 ft
1:30a	0.8 ft
2:00a	0.5 ft
2:30a	0.3 ft
3:00a	0.2 ft
3:30a	0.2 ft
4:00a	0.2 ft
4:30a	0.3 ft
5:00a	0.5 ft
5:30a	0.8 ft
6:00a	1.2 ft
6:30a	1.5 ft
7:00a	1.9 ft
7:30a	2.3 ft
8:00a	2.6 ft
8:30a	2.8 ft
9:00a	3.0 ft
9:30a	3.1 ft
10:00a	3.0 ft
10:30a	2.9 ft
11:00a	2.8 ft
11:30a	2.5 ft
12:00p	2.3 ft
12:30p	2.0 ft
1:00p	1.6 ft
1:30p	1.3 ft
2:00p	1.0 ft
2:30p	0.8 ft
3:00p	0.6 ft
3:30p	0.5 ft
4:00p	0.4 ft
4:30p	0.5 ft
5:00p	0.6 ft
5:30p	0.8 ft
6:00p	1.1 ft
6:30p	1.4 ft
7:00p	1.7 ft
7:30p	2.1 ft
8:00p	2.4 ft
8:30p	2.6 ft
9:00p	2.8 ft
9:30p	2.9 ft
10:00p	2.9 ft
10:30p	2.8 ft
11:00p	2.7 ft
11:30p	2.5 ft
12:00a	2.2 ft
